Surveyor HD Upgrade

It is strongly recommended that all Surveyor HD customers upgrade their PTZ domes to this latest version of firmware, 6.8.82, with UBoot 2.1.1. Included in the updated version of 6.8.82 is a new UBoot Version 2.1.1. UBoot Version 2.1.1 prevents the loss of IP/MAC Address and/or System Parameters that could occur in rare instances of a loss of power during the initial seconds of a power-up cycle. Read through these instructions completely before doing the upgrade.

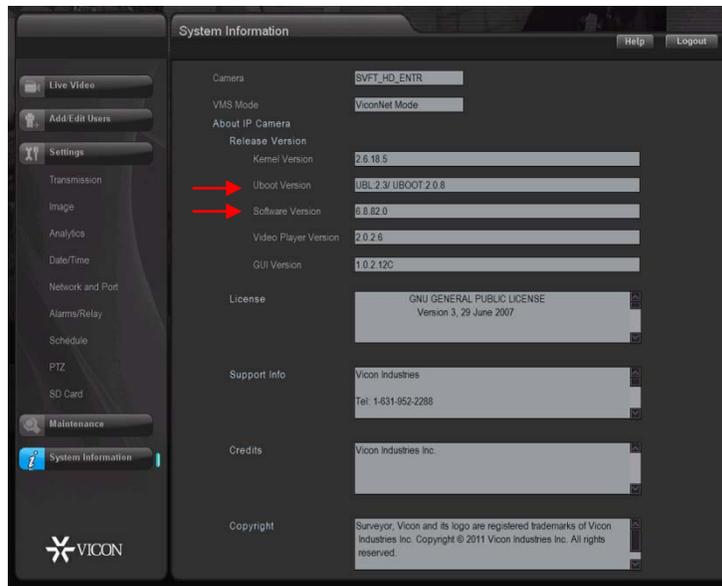
In order to determine which version of firmware your Surveyor® HD is equipped with, log in to the camera's Web Browser and go to the System Information page.

If the software version is 0.7.4.12 or lower, proceed to the 7.4.12 upgrade portion of this document. If the software version is 6.8.82.0 or higher, examine the UBoot Version field; if the UBoot version is not 2.1.1, proceed to the UBoot Version Upgrade portion of this document.

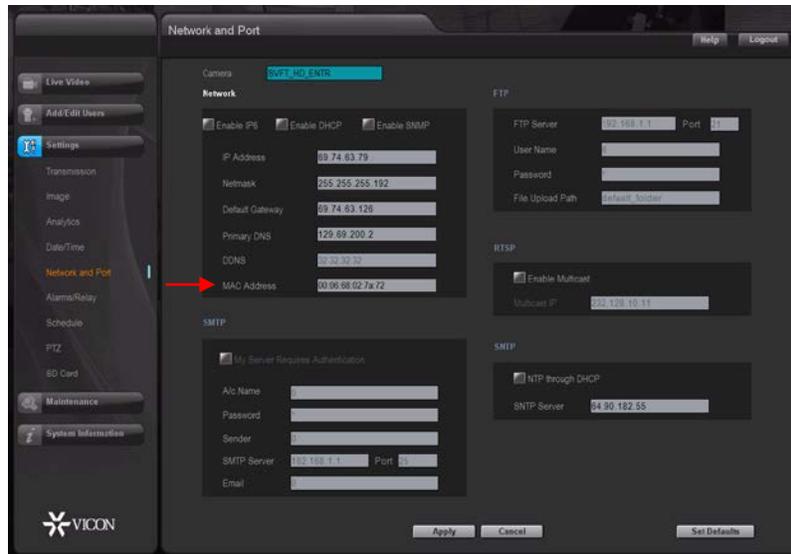
Prior to performing the upgrade, the current MAC Address for the unit should be checked. The MAC Address can be found on the Network and Port page. If the MAC Address is set to aa:d0:b7:bd:f8:f8 then the unit has been set to the default MAC Address. Contact Customer Service and arrange for a replacement unit to be shipped to you.

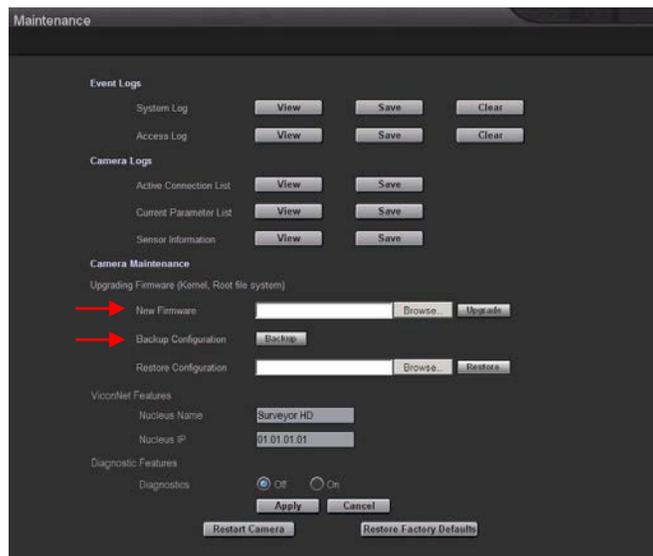
1. After the firmware has been downloaded, go to the Maintenance screen of the camera dome. The following will display.

2. From the New Firmware field, select Browse and go to the location where the fsimage.ulmage.megapixel.tiev.m file has been downloaded. Click the Upgrade button. This will bring the unit up to 0.8.0.0.
3. Restart the camera. When the camera comes up, make sure the splash screen indicates 0.8.0.0; if it does not, repeat the process.
4. To save any configuration settings done through the browser, go to the Maintenance screen and click on Backup.

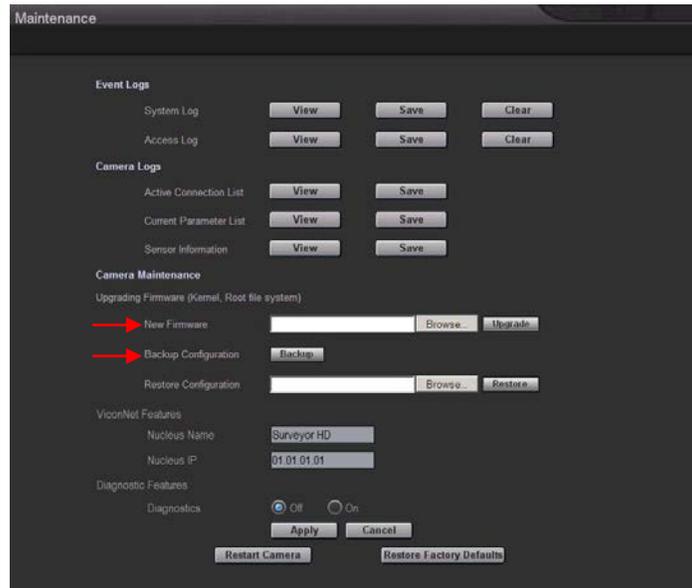
1. After the firmware has been downloaded, go to the Maintenance screen of the camera dome. The following will display.

2. From the New Firmware field, select Browse and go to the location where the UBoot 2.1.1.image file has been downloaded. Click the Upgrade button.
3. Restart the camera. When the camera comes up, make sure the splash screen indicates 6.8.82.0; then proceed to the System Information page and check the UBoot Version. If the version is not 2.1.1 then repeat the process.
