Surveyor HD Upgrade

It is strongly recommended that all Surveyor HD customers upgrade their PTZ domes to this latest version of firmware, 6.8.82, with UBoot 2.1.1. Included in the updated version of 6.8.82 is a new UBoot Version 2.1.1. UBoot Version 2.1.1 prevents the loss of IP/MAC Address and/or System Parameters that could occur in rare instances of a loss of power during the initial seconds of a power-up cycle. Read through these instructions completely before doing the upgrade.

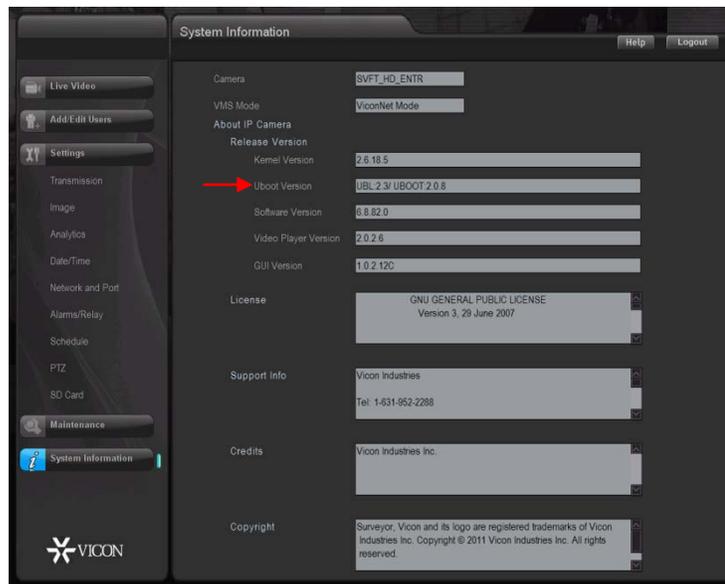
2. From the New Firmware field, select Browse and go to the location where the UBoot 2.1.1.image file has been downloaded. Click the Upgrade button.
3. Restart the camera. When the camera comes up, make sure the splash screen indicates 6.8.82.0; then proceed to the System Information page and check the UBoot Version. If the version is not 2.1.1 then repeat the process.
