9xx Series Cameras Firmware

General Description

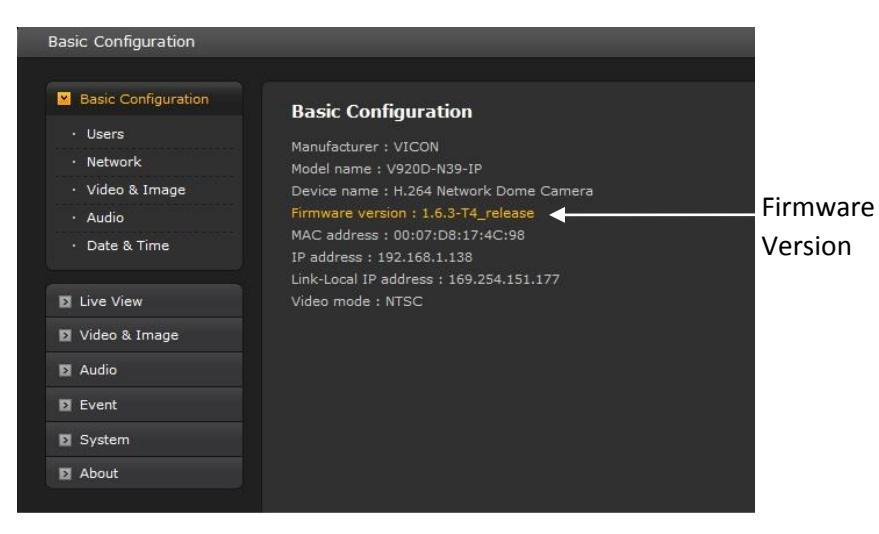
Go to the Upgrade section and use the Browse button to locate the firmware on your PC. Press the Upgrade button. During the upgrade process, so not turn off the power to the camera. Wait at least 5 minutes and access the camera again. The new firmware should be installed. This can be checked from the Basic Configuration screen.
